No-stopping lines in cycle lanes

1. Introduction

This memo discusses the importance of marking no-stopping (“broken yellow”) lines in kerbside cycle lanes. Note that this discussion can also apply to other cycle facilities readily accessible to motor traffic, e.g. “separated cycleways” with an easily-mountable kerb.

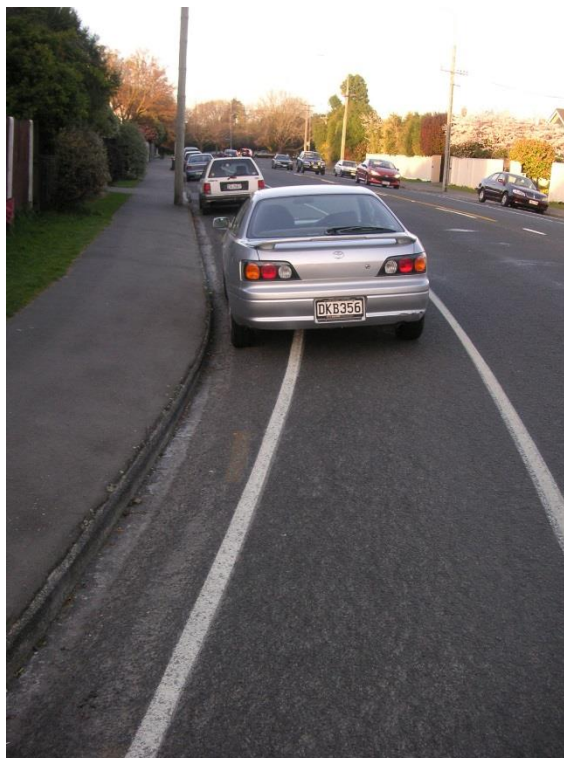
Figure 1: Illegal parking in kerbside cycle lane

The experience of some RCAs (and many cyclists) has been that compliance with the no parking restriction in kerbside cycle lanes is poor. Without installing broken yellow lines, kerbside cycle lanes can be potentially critically compromised. The paper explores the underlying reasons for this behaviour. The Christchurch experiment of trying to educate motorists is commented on. Alternatives to installing and maintaining broken yellow lines are discussed.

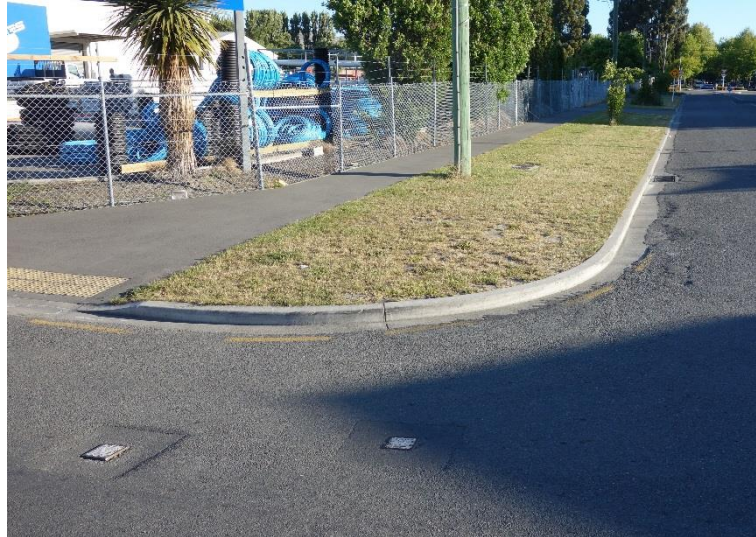
Figure 2: Superfluous no-stopping lines, as stopping within 6 m of an intersection is not allowed

Whilst the definition of a cycle lane under the Road User Rule should in theory mean that it is not necessary to mark no-stopping lines in cycle lanes, this situation can be compared to other locations where the Road User Rule prohibits parking. The Road User Rule also stipulates that a "driver must not stop, stand, or park a vehicle" within 6 m of an intersection (RUR section 6.4), within 6 m of the driver's approach to a pedestrian crossing (RUR section 6.5), within 6 m of a bus stop sign (RUR section 6.8), or within 500 mm of a fire hydrant (RUR section 6.10). Yet those minimum no-stopping restrictions are commonly marked by no-stopping lines, a bus stop marking, or, in the case of the fire hydrant, by a yellow circle, to reinforce what the RUR requires. In other words, Road Controlling Authorities do not rely on the fact that it is illegal to park close to these features, but instead use markings to reinforce this (see Figure 2 for an example). This is presumably because RCAs have experienced that without those markings, compliance might be poor. It is suggested that the same applies to kerbside cycle lanes; without the no-stopping lines, compliance with the no-stopping restriction is poor.

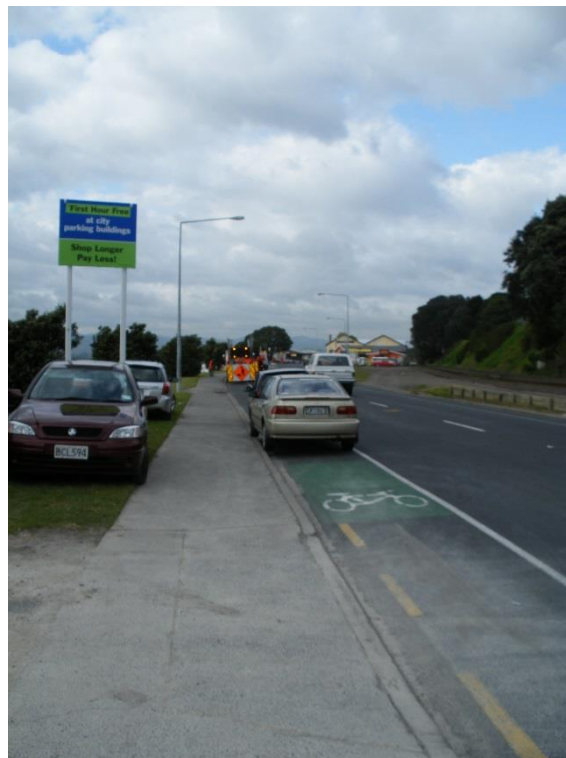
Figure 4 shows two cars owned by traffic engineers parked outside the 2007 Transportation Conference venue in Tauranga. Those drivers assumedly knew that parking in a cycle lane is illegal, and they respected the no-stopping lines and the patch of green, but opted to park in that part of the cycle lane that was otherwise unmarked.

Figure 4: Traffic engineers parked in cycle lanes
