ASSESSMENT OF THE EFFECTIVENESS OF NARROW SEPARATORS ON CYCLE LANES

Keywords: Cycle lanes, Separated Bike Facilities, Safety

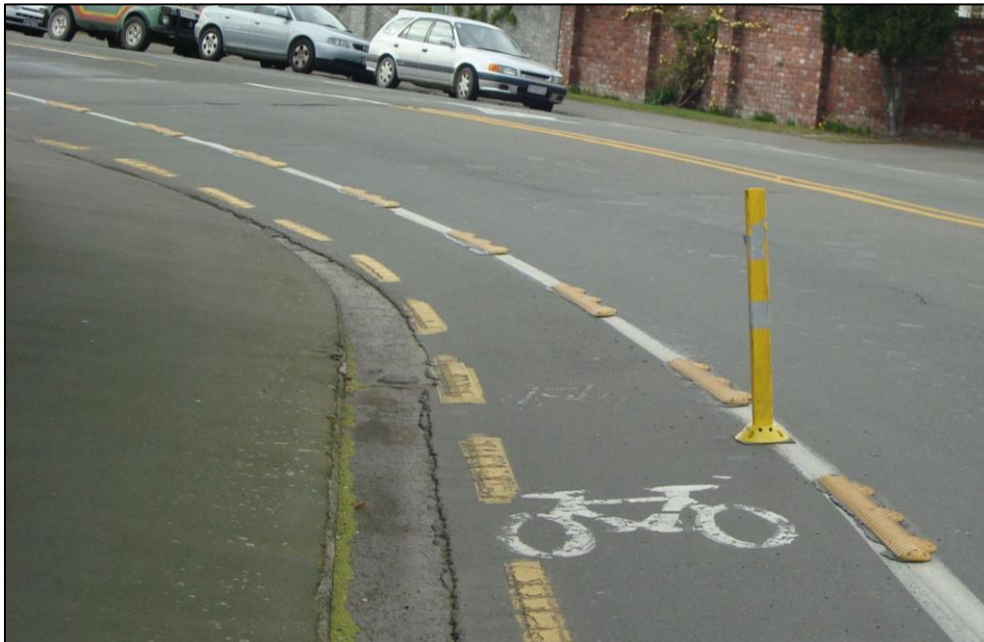
Figure 1: Riley separators and a vertical post installed on Kotare Street cycle lane line

Width	100 mm (160 mm to bumps)
Height	25 mm
Edge lip height	2-3 mm
Surface	Moulded pimples rising approx. 2 mm above surface
Reflectors	Small reflectors moulded into leading edges
Comments	1.2 m long sections; may be installed with a gap for drainage and cyclist entry/exit.

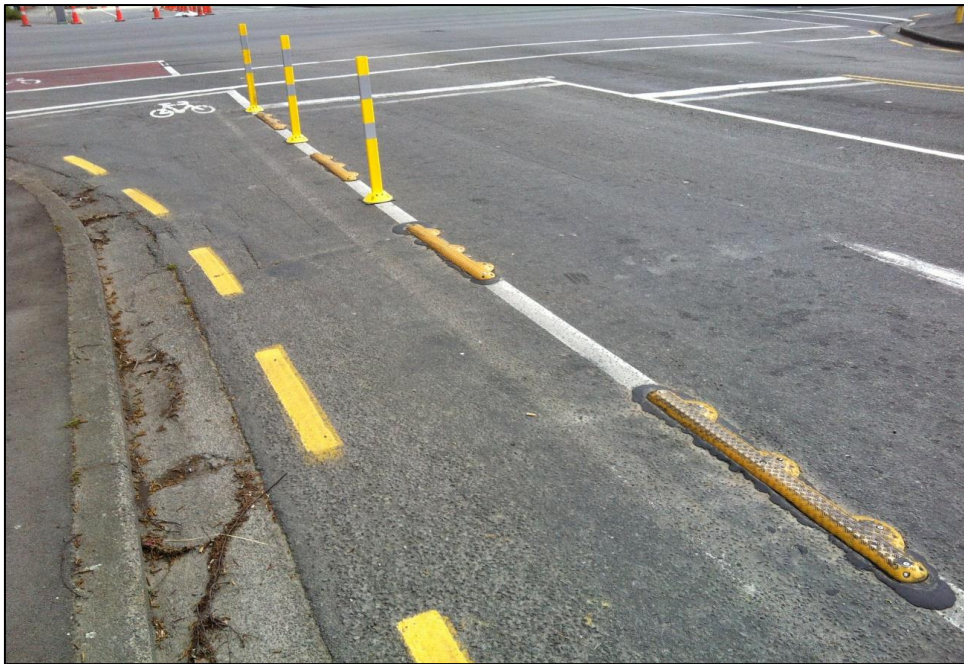
Figure 2: Strickland Street Riley separators and posts approaching intersection

After implementing the separators on Strickland Street, their position was re-evaluated. The result was a slight shift of the separators to their current position on top of the existing cycle lane marking. However, the initial post-implementation survey made clear that many motorists were still ignoring the separators. Three flexible posts were subsequently installed to physically underline the separation between cyclists and motor vehicles (see Figure 2) and a third video survey was collected.

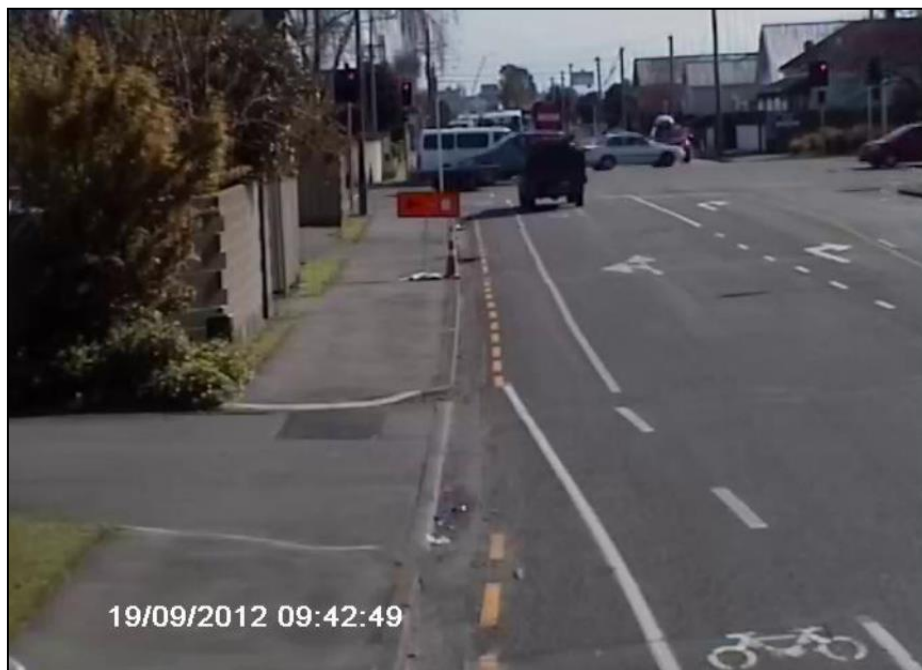
Figure 3: Camera angle, first post-implementation survey (Strickland Street)

The first survey was observed from a side-on position that provided good detail at the intersection, but little about the approach. During the first post-implementation survey, the position of the observation vehicle was changed to get a better impression of the queuing behaviour of approaching vehicles (see Figure 3). While the categorisation of driver behaviour remained unchanged, the cyclist waiting area was not clearly visible and, often, the encroachment level of vehicles in this area had to be guessed.

For the second post-implementation survey, the position of the observation vehicle remained the same as during the first post-implementation survey. However, the camera angle was zoomed slightly closer to the intersection to get a better view on the separators.

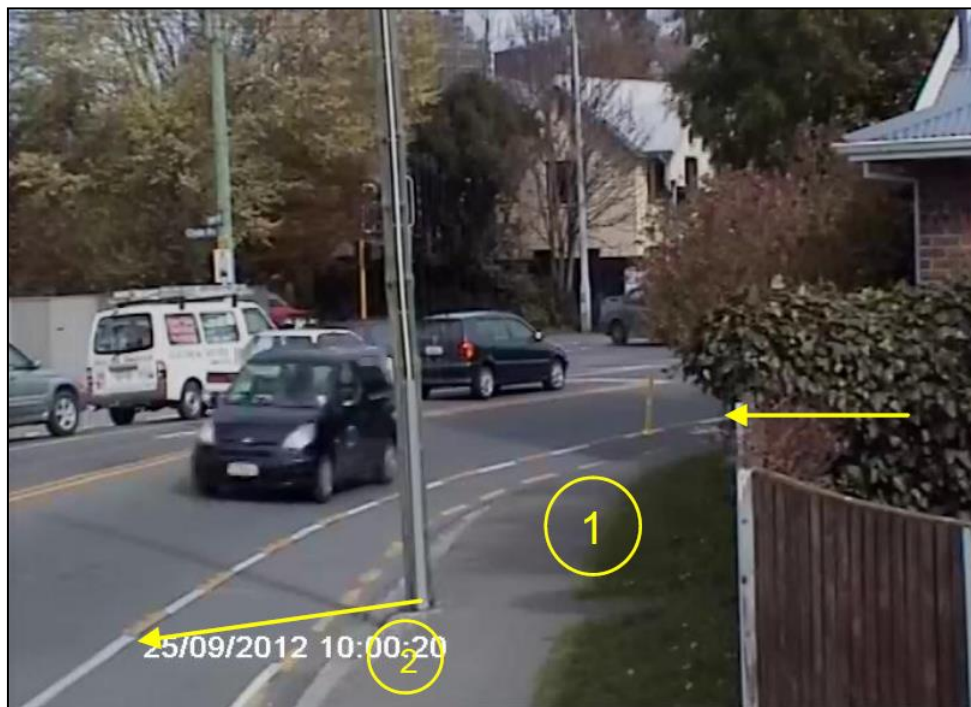
Figure 4: Kotare Street encroachment zones as viewed from camera

During the pre-implementation video evaluation, the research area was split up in three sections. Section 1 covered the length of the separators, Section 2 extended from the end of the separators a similar distance downstream, and Section 3 continued beyond that. During the post-implementation survey, the camera angle mostly focused on Section 1 (see Figure 4). Therefore, the remaining two sections were combined into one.

Vehicle movements were categorised as fully or partly encroaching into any of these sections. Motor vehicles were rated as fully encroaching, when they were taking all space from cyclists. If motor vehicles entered the cycle lane with one wheel or drove on the cycle lane marking, they were categorised as partly encroaching.

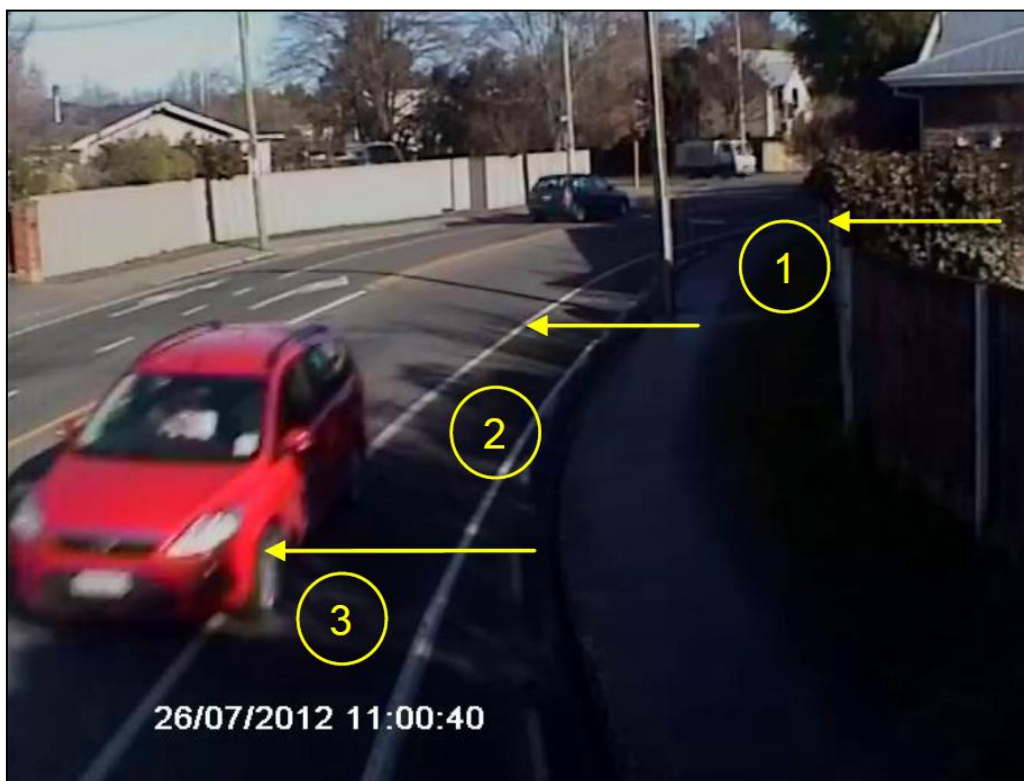
Figure 6: Partly encroaching motor vehicle in Section 2+3 (Kotare Street)

During the survey period on 26 July 2012, over 2500 motor vehicles were observed. Over half of the vehicles did not encroach into the cycle lane at any time while driving along Kotare Street. Motorists entering the cycle lane were most likely to encroach into only one of the three sections, although encroachments of two or three sections were also reasonably prevalent (see Figure 6).

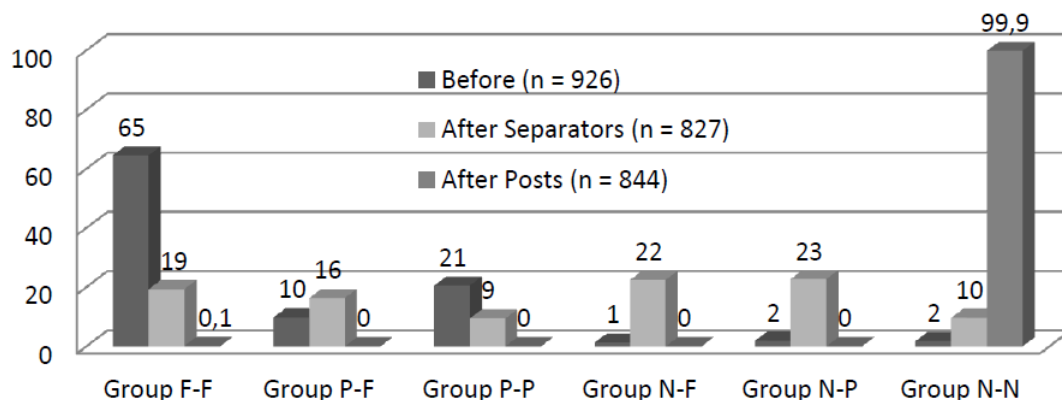
Figure 7: Before/After: driver behaviour during full traffic sequence (Strickland Street)

Comparing the results of the three different surveys (see Figure 7, values shown are percentages; refer to Table 2 for the encroachment group definitions), a reduction in encroachment during the full traffic signal sequence is obvious. While more than half of the motor vehicles encroached completely before the separator implementation, those numbers decreased immensely after the separators were installed. The proportion of encroachment decreased even more after implementing the vertical posts. Due to their position and appearance, the posts made it virtually impossible to encroach into the cycle lane, when vehicles were positioned in the traffic lane.

Regarding the two signal stages separately, the increase of no-encroachment is equally significant. During the red signal phase, driver behaviour changed drastically from nearly 2/3 of the queuing vehicles encroaching completely before the implementation to more than 50% not encroaching vehicles after the implementation of the low-profile separators. After the implementation of the vertical posts, the non-encroachment grew to almost 100%. This comparison shows the influence of the different separator types.

During the green signal phase, the behaviour change was less drastic, but still obvious. Implementation of the low-profile separators saw full encroachment drop from 76% to 58%, with corresponding increases in partial and no encroachments. Once the vertical posts were installed, encroachment into the cycle lane while turning left was virtually impossible, leading to near 100% compliance.

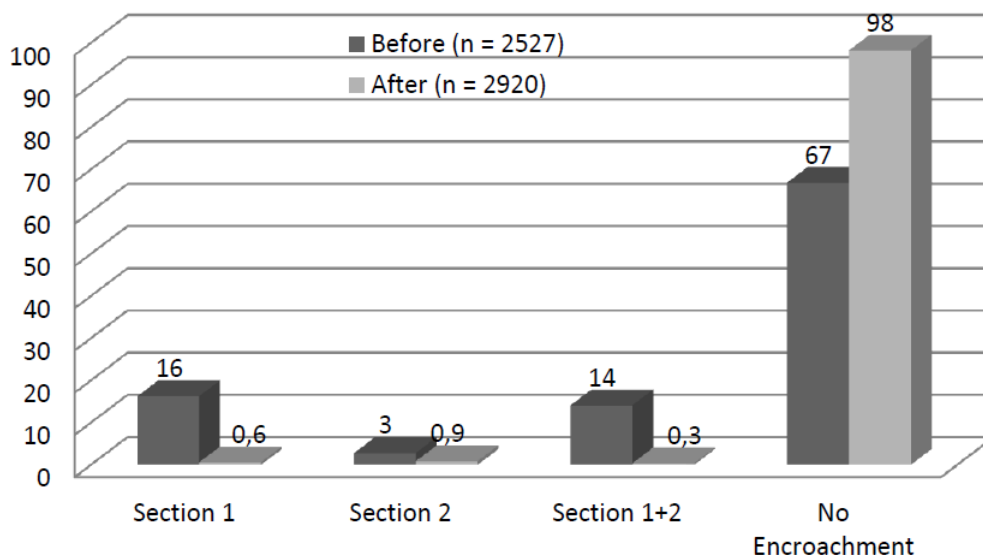
Figure 8: Before/After: driver behaviour change (Kotare Street)

As seen in Figure 8, implementing separators and a flexible post on Kotare Street led to a near-elimination of encroachment. This underlines the effectiveness of the treatment at mid-block area. A minority still encroached into the cycle lane, but was significantly reduced compared to the pre-implementation survey results.

The Chi-Square test was used to analyse the statistical significance of the implementation of cycle lane separators and a flexible post on Kotare Street, in terms of encroaching vehicles compared to not encroaching vehicles. With one degree of freedom, the Chi-Square test statistic of $X^2=974.3$ indicates a high statistical significance of the evaluated behaviour change ($p<0.005$). This result underlines the impression that combining cycle lane separators and flexible posts is effective to prevent motorists encroaching into on-street cycle lanes in mid-block areas.
