Signalised Roundabout Design for Pedestrian and Cyclist Safety

IPENZ Transportation Conference November 2008 – Technical Note

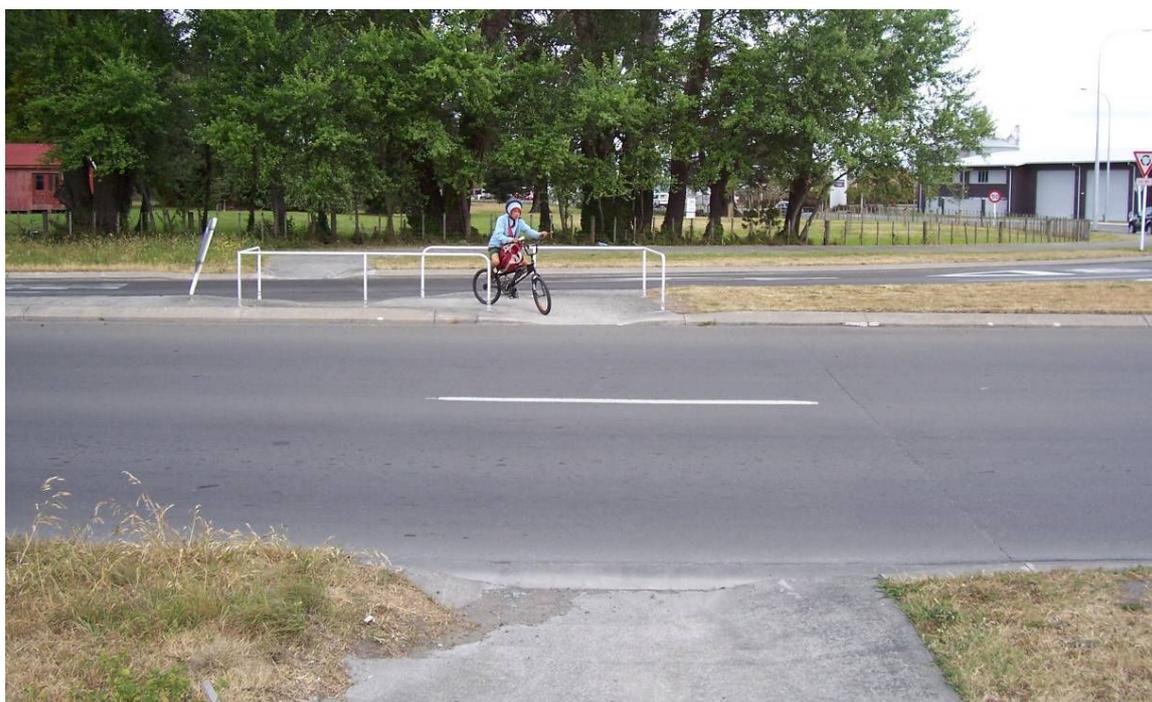
Figure 1: Crossing facility for the 100 km/h road . Roundabout located 30 m to the right.

Pedestrians and cyclists crossing the 100 km/h road are provided for by off-road crossings away from the roundabout (as shown in Figure 1) and off-road paths around the outside of the roundabout linking to the 50 km/h road. The pedestrian and cycle crossing facilities are located some 30 m away from the roundabout's circulating roadway.

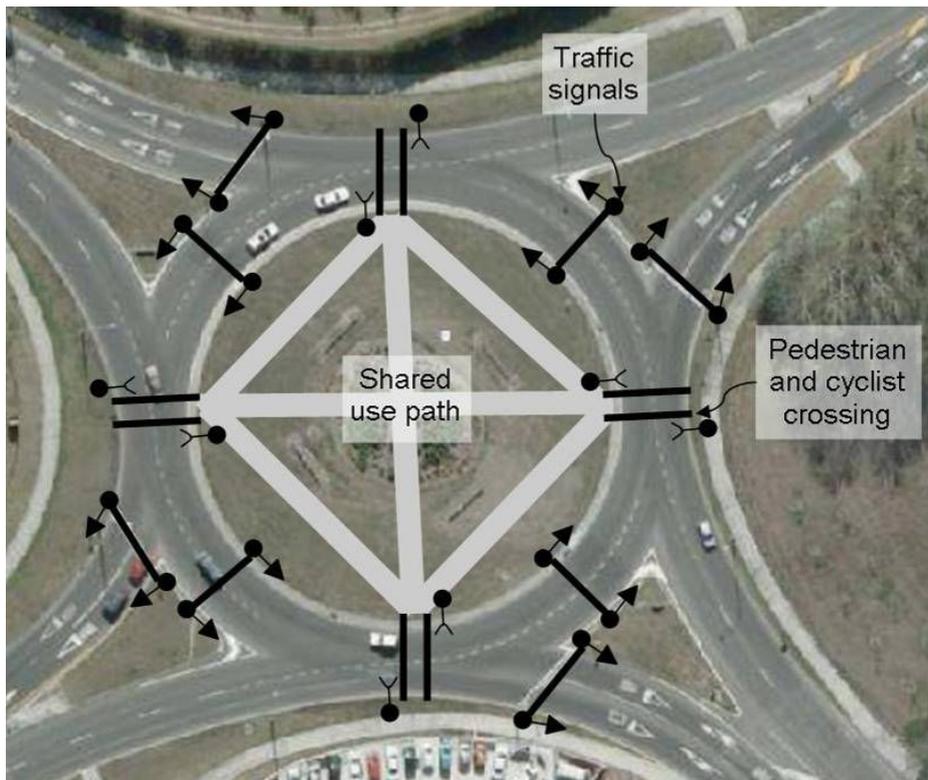
Figure 2: Concept plan for location of signal hardware and crossing points

A number of options were considered for this intersection. These included grade separation and conventional traffic signals. The recommended long-term solution, however, was to signalise the existing roundabout. This would allow for safe and efficient crossing by pedestrians and cyclists by requiring motor vehicles to stop when pedestrians or cyclists are present. Figure 2 indicates where signals, limit lines and crossing points would be located. Every entry to the roundabout would be controlled, as well as the circulating traffic approaching each entry. Crossing points located downstream of the entry points would not require traffic signals (only pedestrian/cycle crossing signals) as all traffic approaching the crossings would be controlled by signals.

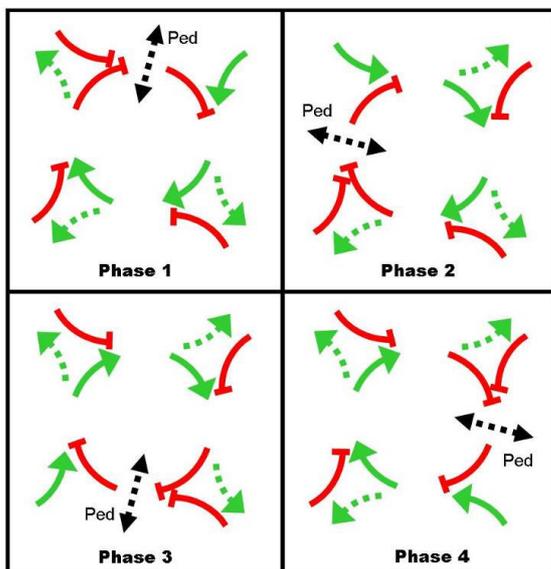
The phasing diagram shown in Figure 3 shows how the signals could be operated. The operation involves four phases. During each of these, pedestrian and cycle movements are allowed and conflicting traffic movements are prohibited.

Figure 3: Suggested phasing structure (with crossing demand)

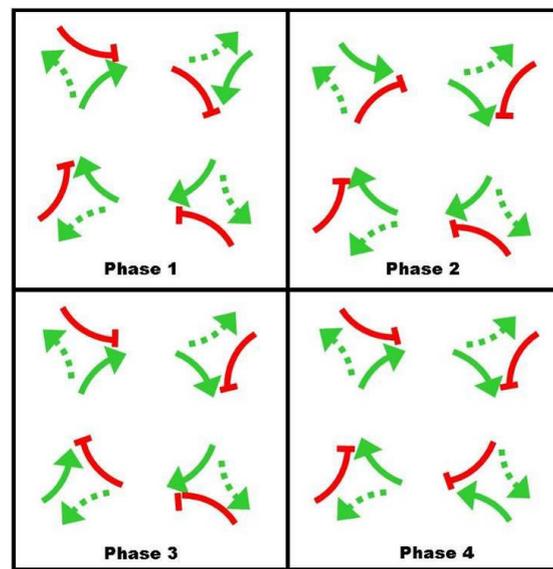
Figure 4: Phase without crossing demand

If in any one phase, the pedestrian crossing demand is not called, an additional circulating flow can be accommodated, as shown in Figure 4.
